SANTOS MEMORIAL PARK FEASIBILITY STUDY

Santos Memorial Park Feasibility Study

Executive Summary

The Bureau of Statistics and Planning through the Department of Public Works (Project No. 310-5-1022-F-PIT) have hired the services of Duenas Camacho & Associates (DCA) to provide archeological, architectural, geotechnical, structural, civil, mechanical, electrical engineering, and environmental services to initially investigate the feasibility of improvements and controlling soil erosion occurring in and around Santos Memorial Park. The project objectives are to assess existing site conditions, develop feasible alternatives for storm water and other park improvements, and to provide complete design services for the preparation of plans, specifications, and estimates needed to procure construction bids for an acceptable program of improvements.

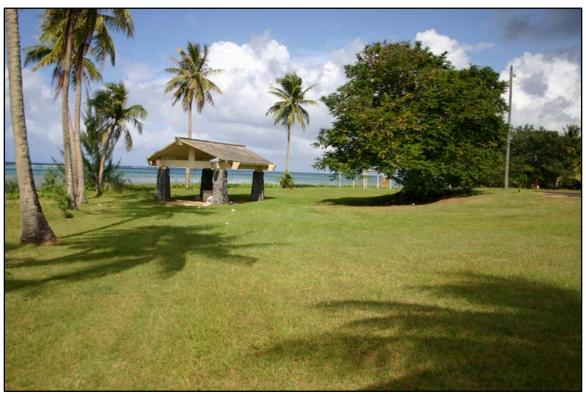
Figure 2. Shrubs and Coconut trees planted for shoreline erosion control.

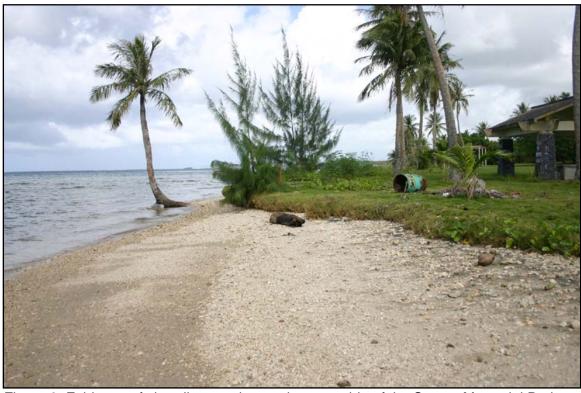
Figure 3. Evidence of shoreline erosion on the west side of the Santos Memorial Park.

No threatened or endangered plant and animal species were observed at the Santos Memorial Park project site. Vegetation is especially dense at the southwest side along the riverbanks of Masso River with tangan-tangan (Leucaena leucocephala) and pago (Hibiscus tilaceus). Several ironwood (Casuarina equisetifolia) and coconut trees (Cocos nucifera) are along the shoreline and were previously planted as a shoreline erosion control measure (Figure 2). However, the northwest side of the beach front has visible signs of shoreline erosion despite the presence of turf grass (Figure 3). Currently, the

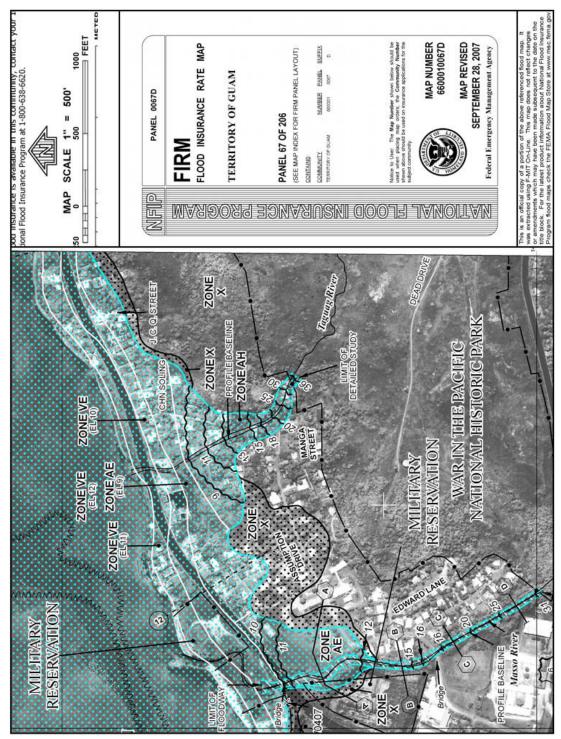
Figure 4. Flood Insurance Rate Map (FIRM) of Santos Memorial Park, Piti, Guam.

Flood hazard classification for the proposed project site was determined from the FEMA Flood Insurance Rate Map (FIRM) (Figure 4). Santos Memorial Park is designated as a high risk area with a Flood Zone VE designation, which are for coastal areas with a 1% or greater chance of flooding and an additional hazard associated with storm waves. These areas have a 26% chance of flooding over the life of a 30-year mortgage.

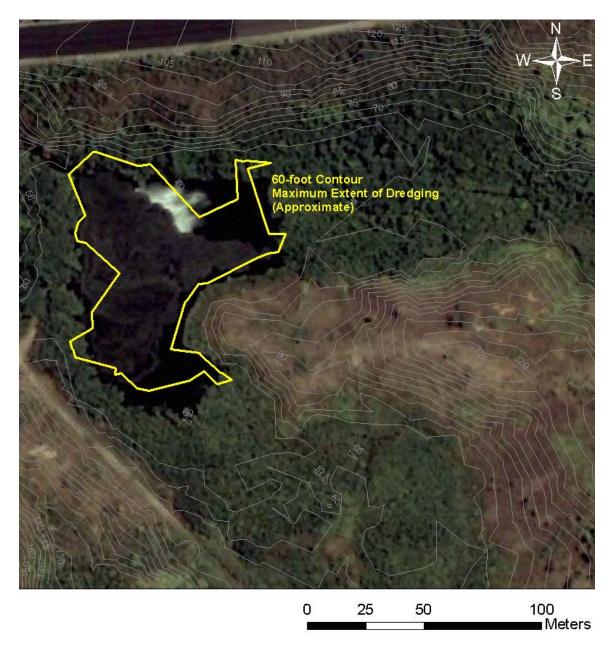
Figure 5. Map illustrating extent of proposed dredging at Masso Reservoir.

The proposed rehabilitation of Masso Reservoir would consist of dredging the Masso Reservoir, constructing a perimeter fence to keep ungulates out, and constructing a fishing platform on the west end of the reservoir. For the dredging operation, a portion of the vegetation on the periphery of the reservoir would be cleared to allow the excavators to pass through. The Masso Reservoir would be dredged up to the 55-foot elevation contour (Figure 5). In addition, reforestation of the upstream portion of the Masso River and upland areas will be done by the Department of Agriculture's Forestry Division. Necessary federal and local permits for these proposed actions have been secured, and construction is slated to begin in March 2009. It is anticipated that dredging the Masso Reservoir would remove a significant amounts of fine sediment particles which have settled at the bottom of the reservoir over time.

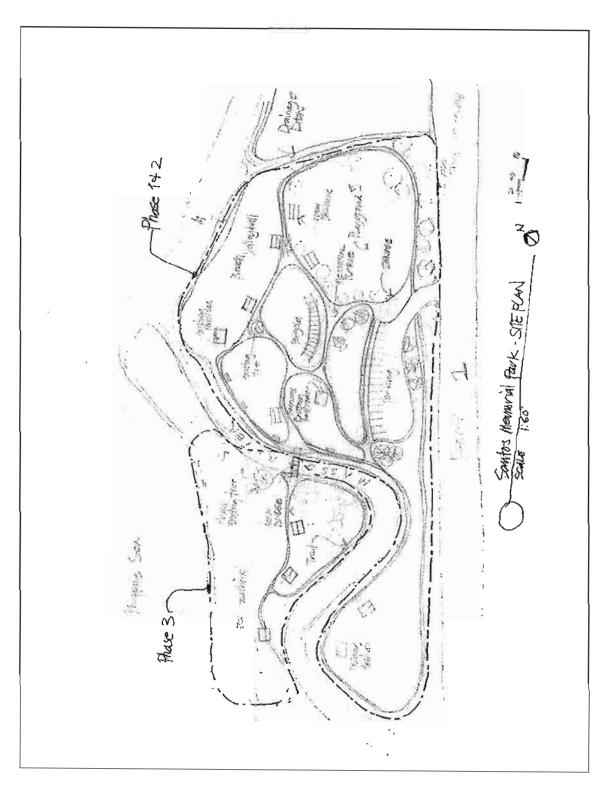
Figure 2. Preliminary sketch of the proposed improvements at Santos Memorial Park, after Duenas, Bordallo, Camacho and Assoc.

As shown on Fig. 2, the proposed improvements to the park include constructing additional picnic pavilions, a playground, pathways, jogging trails, a small foot bridge across the river, and a defined parking area. The existing restroom facilities will be upgraded and refurbished. In addition, lighting, a memorial plaque and signage will be installed and the area will be landscaped. The proposed work will be carried out in three phases. Phases 1 & 2 will be completed first and this area was the focus of the present archaeological testing program. Phase 3, on the west side of the Masso River, will take place sometime in the future, when additional funding is available.

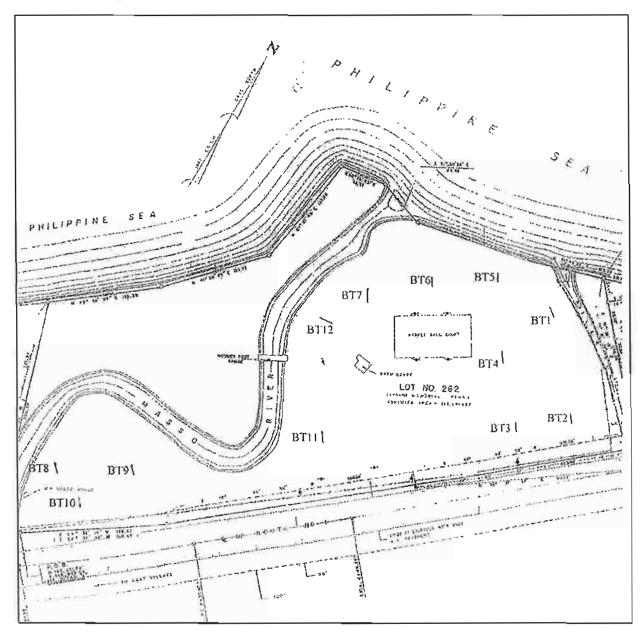
Figure 9. Plan of Santos Memorial Park showing the locations of Backhoe Trenches 1-12. Note the line pointing to the Old Masso Bridge in the lower left hand corner of the project area.

The backhoe trenching was accomplished December 1 and 2, 2008. Twelve trenches were dug (Fig. 9). Archaeologists in the field were Judith R. Amesbury and Darlene R. Moore. Backhoe service was provided by International Consolidated Contracting, Tamuning. The field work was guided by the Scope of Work approved by the Guam Historic Preservation Office. The scope called for 6 to 8 trenches to be dug; 12 were completed.

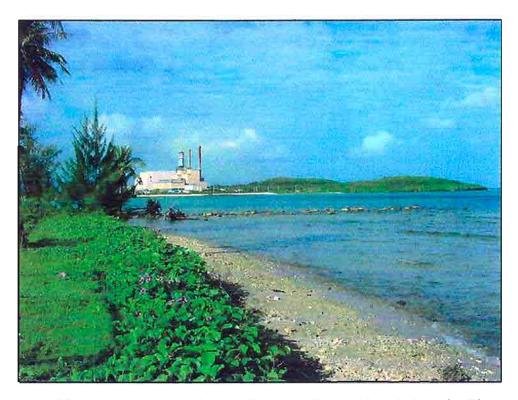
Photo 2. View of Santos Memorial Park's eroding shoreline and beach deposit. The power plant and Cabras Island are in the background.

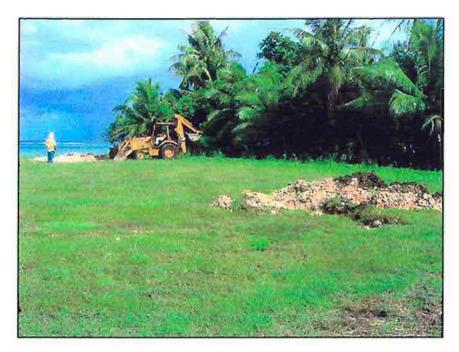
Photo 4. View of the east side of the project area. BT 2 is on the right and BT 1 is on the left. The camera is facing northeast.

BT 1-BT 5 were dug on the east side of the project area, east of the basketball court. Photo 4 is an overview of the BT 1-2 area with the drainage ditch in the background.

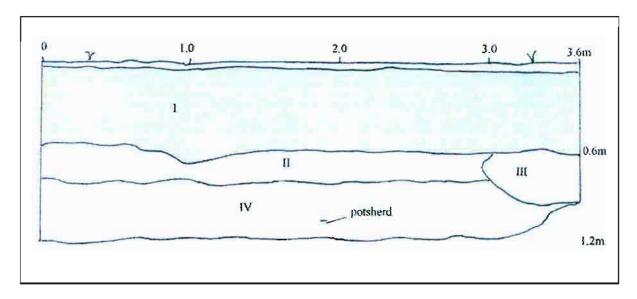
Figure 10. West face of BT 1. The uppermost portion of the deposit is humic topsoil. Layer I is a deposit of introduced quarried limestone base course. Layer II is dark brown clay containing a marine shell and a small historic ceramic fragment. Layer III is black clay. Layer IV is brown clay containing a few eroded pottery sherds, one in the trench wall about 104 cmbs. Also recovered from the brown clay was a slab of tuffaceous sandstone (see below).

The west face of BT 1 is shown in Fig. 10 and see Photo 5. A 20 cm thick layer of dark brown clay (II) occurs below the quarried limestone base course (I). From 80 to 120 cmbs there is a layer of stiff brown clay (IV). A slab of green tuffaceous sandstone (possibly cultural) and five pottery sherds were recovered, one from 104 cmbs (shown on Fig. 10). The pottery sherds are eroded. Exposed at the north end of the trench there was a lens of black clay extending from 60-80 cmbs. A soil sample was taken (Cat. No. 2). The laboratory examination of this soil suggests that it contains the same elements as the natural occurring black sand that was collected from the beach.

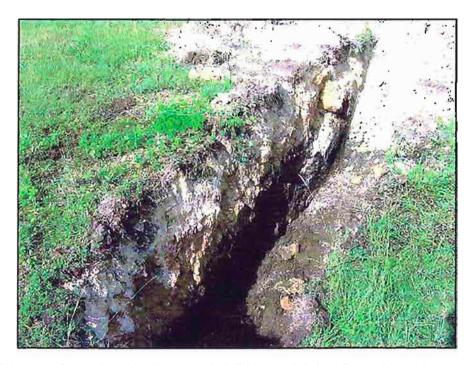
Photo 5. BT 1, west face, showing the quarried fill material that forms Layer I.

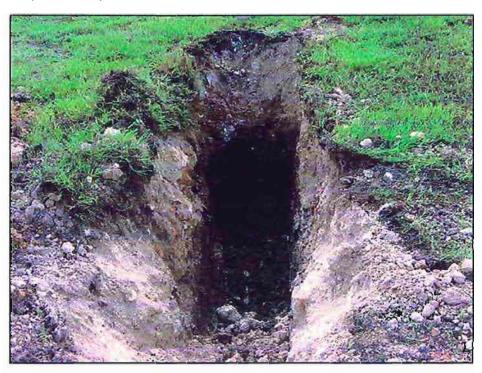
Photo 6. BT 2 showing the south end of the trench. The light material is the quarried fill that overlies the brown clay.

BT 2 was situated on the southeast side of the project area. The humic topsoil was 0-5 cm thick. From 5 to 65 cmbs there was an introduced layer of fill (Photo 6). From 65 to 120 cmbs there was a stiff, reddish brown clay layer that was culturally sterile. One *Anadara* antiquata shell (Cat. No. 6) was collected from the back dirt.

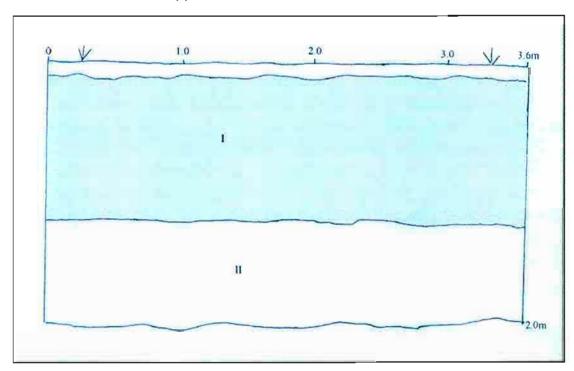
Figure 11. East face of BT 5. In this area the humic topsoil is .18 m thick. Layer I is introduced quarried limestone fill to a depth of 1.08 m. Layer II is moist brown sandy clay containing glass fragments, metal, plastic, and a few historic ceramic pieces, mixed with marine shells and a few eroded pottery sherds.

The east face of BT 5 is shown in Fig. 11. This 4.0 m long trench was located east of the basketball court and east of the large tree near the beach. Its north end was 10 m south of the inland edge of the beach. The trench was 2.0 m deep and the water table was reached at a depth of 1.75 m. The introduced fill (I) was 1.08 m thick.

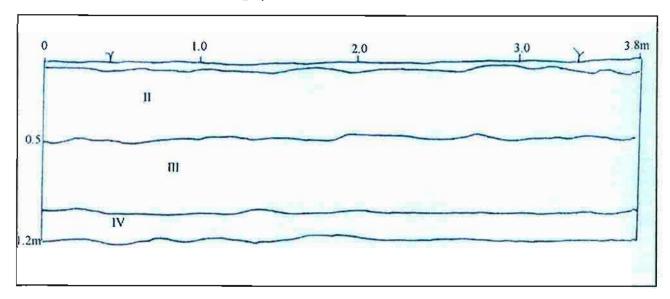
Figure 12. West face of BT 6. This trench lacks Layer I, which is the introduced fill material. Below the humic topsoil is Layer II, light brown sand that contains the shells of African Land Snails, pieces of glass from beverage bottles (Coca Cola, Byerly, beer) and marine shells. Layer III is culturally sterile, brown sandy clay. The water table was reached at 1.0 m and a wet gleyed deposit (IV) occurs from 95 cmbs to the base of the trench at 1.2 m.

BT 6 and 7 were located north of the basketball court on either side of the beach pavilion. The east face of BT 6 is shown in Fig. 12. The north (seaward) end of the trench is 12.3 m south of the eroded edge at the inland edge of the beach and the south end of the trench is 11 m east of the southeast pillar of the beachside pavilion. Immediately south (inland) of the trench the ground surface begins to rise for the basketball court. There is no introduced fill in the trenched area. A 45 cm thick layer of brown sand occurs below the 4 cm thick humic topsoil. The light

brown sand contains the shells of African land snails, pieces of bottle glass (CocaCola, Byerly, various beers), scattered marine shell, and coral fragments. Below this modern layer was a 44 cm thick, culturally sterile, layer of brown sandy clay. The water table was reached at 100 cmbs, and the moist soil at that level was gleyed sand. No collection was made.

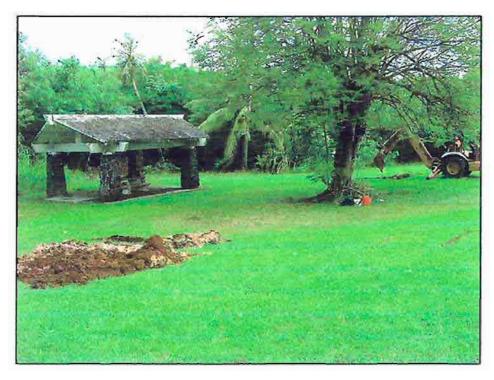
Photo 7. View of the west side of the project area. BT 8 is in the foreground, BT 9 is in the background (by the backhoe), and the inland picnic pavilion is to the left. The old road bed does not show in this photo, but it would be to the right. The Masso River channel is behind the pavilion.

Three backhoe trenches (BT 8, BT 9, and BT 10) were dug in the southwestern portion of the project area (Photos 7-8). BT 8 was furthest west. The trench was 3.5 m long, .75 m wide, and 1.55 m deep. From 0-16 cmbs was humic topsoil. From 16-66 cmbs there was a layer of introduced sand, apparently dredged from the reef. The sand contained abundant broken coral and marine shell. From 66-155 cmbs there was a mottled, reddish brown clay. The clay contained no reef material. From the back dirt were recovered a *Terebra maculata* shell, a butchered mammal bone, a sample of decaying wood, and an historic ceramic (Cat. No. 10). The wood was sent to Hawaii for identification (Appendix B). It was identified as possible *tangantangan*.

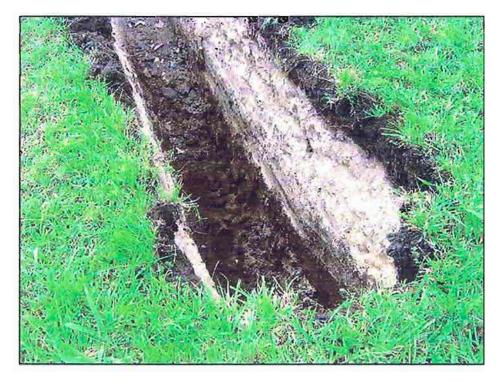
Photo 8. BT 8, west face. The light material is sand dredged from the reef flat.

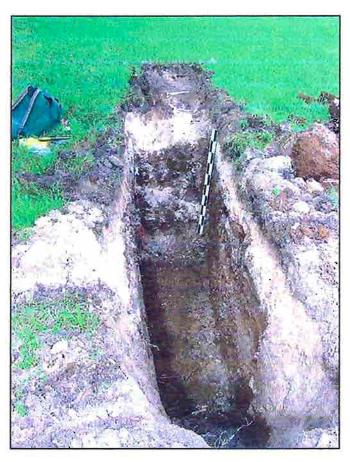
Photo 9. View of the east face of BT 9. The meter stick is at the north end of the trench. The light material is fill material dredged from the reef flat. A waterline is exposed behind the meter stick.

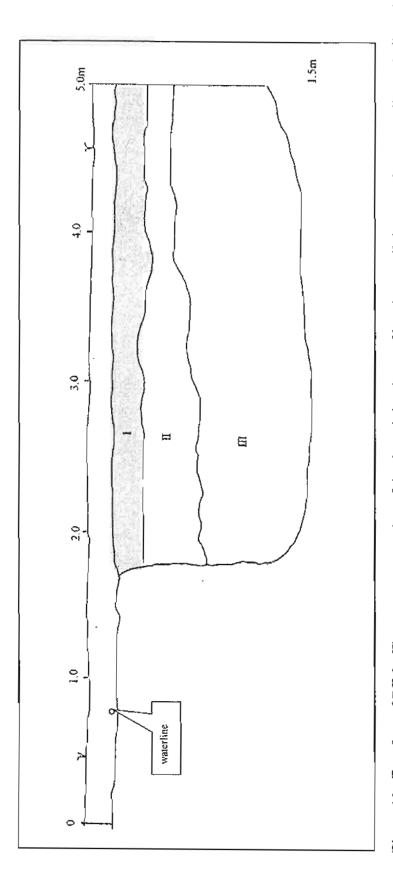
Figure 13. East face of BT 9. The uppermost portion of the deposit is a layer of humic topsoil that contains a waterline as indicated brown clay with charcoal flecks, glass fragments, unidentified metal, several small fragments of historic ceramics and the base of a by the small circle in the shallow portion of the trench. Layer I is fill consisting of dredged material from the reef flat. Layer II is probable rice bowl recovered 44cmbs. Layer III is culturally sterile reddish brown mottled clay with few roots.

The east face of BT 9 is shown in Fig. 13. The topsoil in this area is 18-20 cm thick. A waterline, perhaps running to the picnic pavilion located in this area, was exposed at the north end of the trench about 20 cmbs. From 18 to 36 cmbs there is an introduced deposit of dredged sand and fragments of branch coral (I). Below that (36-70 cmbs), there is a layer of charcoal flecked brown clay (II) that contains a scattered mixture of historic material. A piece of metal and the base of a probable rice bowl was recovered from this layer about 44 cmbs. Below the brown clay (II) there is a deposit of reddish brown mottled clay (III). This culturally sterile layer contains few roots, no shell or other reef material.

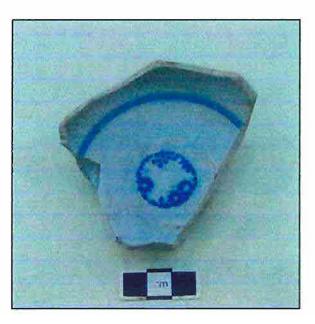
Photo 10. Stoneware rice bowl from BT 9. The scale is 3 cm long. Left, footrim and exterior. Right, center medallion and interior.

Twelve pieces of historic ceramics were recovered (Table 2). Most were too small to provide information about the vessel form from which they originated (Photos 10-11). The most complete piece was the base of a probable rice bowl recovered from BT 9 (Photo 10, left). The footrim of this stoneware bowl has an exterior diameter of 41 mm and it is 9 mm high. The footrim exterior is trimmed with a blue band. Another blue band marks transition from the footrim to the lower portion of the wall which has a series of blue stenciled triangles near the base.

The piece is too small to provide an accurate estimate of the bowl's overall diameter and height. The bowl interior has a small central medallion with a blue floral design and a blue line which marks the point where the bowl walls meet the base (Photo 10, right). The diameter of this blue circle is 62 mm. According to local archaeologist and ceramic specialist, Lon Bulgrin (pers. comm. 2009), this type of stenciled stoneware was made in Japan during the period from 1880-1914. It is likely that it was brought to Guam by one of the Japanese trading vessels that operated in the Marianas during that time.

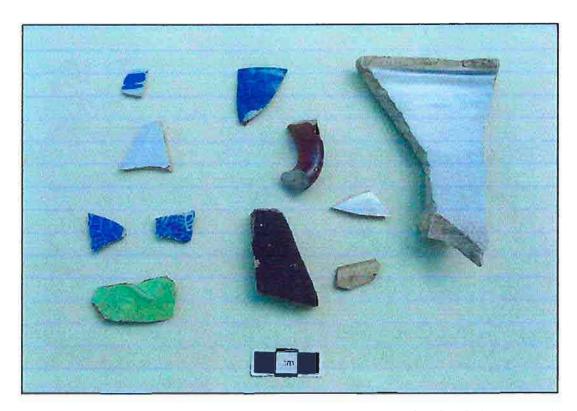
Photo 11. Historic ceramic fragments. The scale is 3 cm long. Left side of photo: top, rim with blue band=BT 1, Layer II; middle, white piece=BT 8 back dirt; lower, two blue and one green piece=BT 9. Right side of photo: top, blue rim, brown handle, and two white pieces=BT 5; lower, brown and beige pieces=BT 10.

The three small porcelain pieces with blue transfer print designs on their surfaces (Photo 11) are likely to have derived from small rice bowls made in Japan. Fragments such as these are fairly common in Guam's archaeological deposits with an historic component. This type of bowl was probably imported to Guam from the late 1800s to as late as 1944.

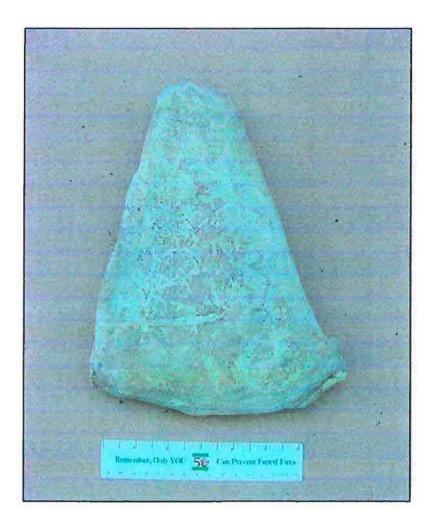
Photo 12. Slab of green tuffaceous sandstone from BT 1. The scale is 15 cm long.

A slab of pale green tuffaceous sandstone (Cat. No. 3) was recovered from the brown clay of BT 1 (Photo 12). The slab is roughly trapezoidal. The two non-parallel sides measure 25 cm, while the two parallel sides measure 20 cm and 6 cm. Thickness of the slab varies from 19.3

to 28.7 mm, and weight is 4 pounds 12 ounces. The slab may have been shaped by a person. The two long sides appear to be shaped and or smoothed.
